## Fiberglass Storage Tank Inspection Procedures Gain Traction in the US

Gary Arthur, *President at Fiberglass Reinforced Plastics Institute, Inc.*

JULY | AUGUST 2024

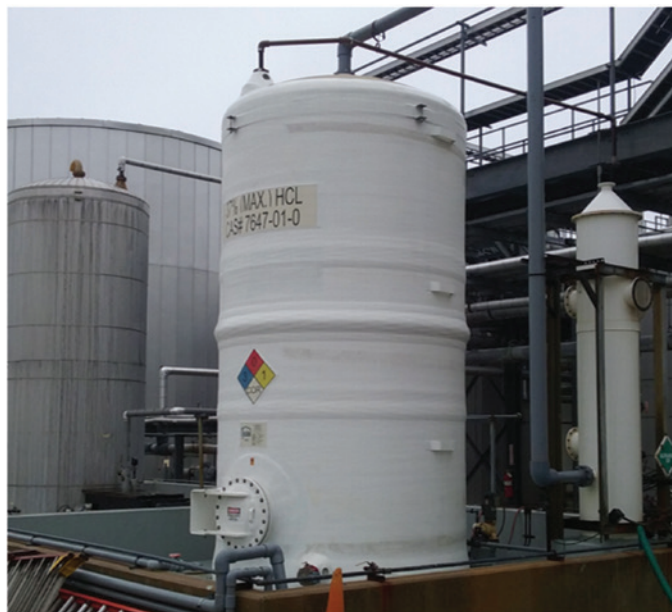
Figure 1. Hydrochloric acid tank.

US Federal and State regulations related to the storage of hazardous substances, such as hydrochloric acid (see **Figure 1**), were enacted decades ago to ensure environmental protection and worker safety. These regulations require ASTs to be inspected following the most recently promulgated Recognized and Generally Accepted Good Engineering Practices (RAGAGEP). FRPI inspection procedures are the most recent RAGAGEP per EPA guidance and OSHA interpretation, providing owners and inspectors a means of compliance with laws.

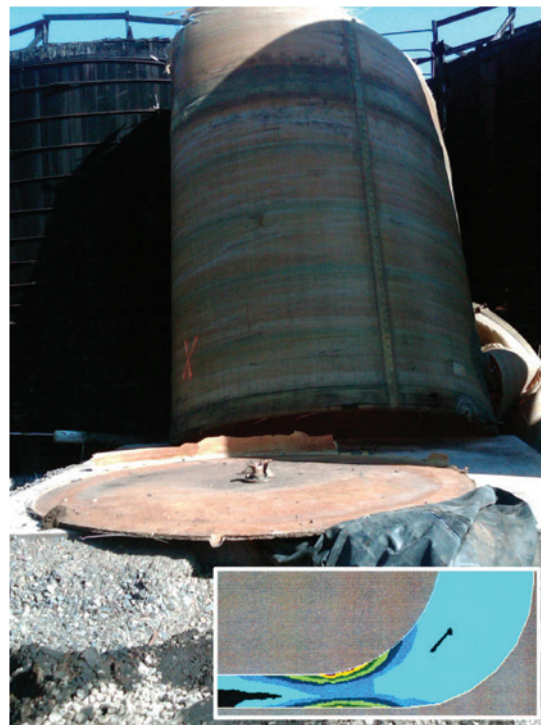
A critical inspection zone for fiberglass ASTs is the bottom knuckle area. Finite element analysis shows the high stress zone in red (see **Figure 4**). Over time, with resin attack, permeation and stress, the bottom adjacent to the knuckle radius typically shows signs of degradation. Although possibly difficult to see, but easily considered if the inspector is properly qualified and following a detailed inspection procedure, this known failure mode could appear as inner corrosion barrier crazes and/or suggest evaluation of stress corrosion modulus decay. This catastrophic tank failure could have been prevented.

**Figure 4.** Catastrophic failure of acetic acid tank.

In this case, a 43-year-old 20,000-gallon acetic acid tank bottom suffered a catastrophic failure, spilling its contents into marginal containment. Under the NYS DEC Chemical Bulk Storage Rules and Regulations in the US, this tank had been undergoing inspections at 5-year intervals. Because it had a capacity greater than 10,000 gallons, the tank was also subject to inspection under a qualified engineer and, where necessary, an internal inspection among other suggested scope should be considered. The regulations are assumed to prevent failure, assuring environmental protection and safety.

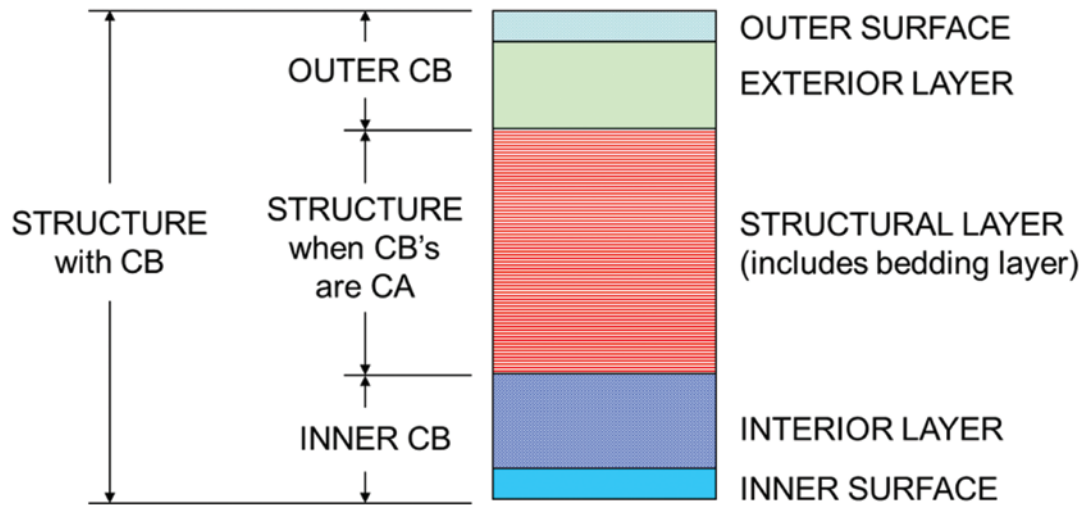
Figure 5. Cross section of laminate.

Identification, provide a procedure to identify, describe, and illustrate the laminate design basis [16]. This procedure puts ASTM and ASME material standards into action, where laminates are described by classifications, composition plus visual observations of reinforcement textures and sequence, inner surface mold impressions, outer surface patterns, and polymer components. Recognizing and correctly characterizing laminates by layer is a cornerstone of AST inspection (see **Figure 5**).

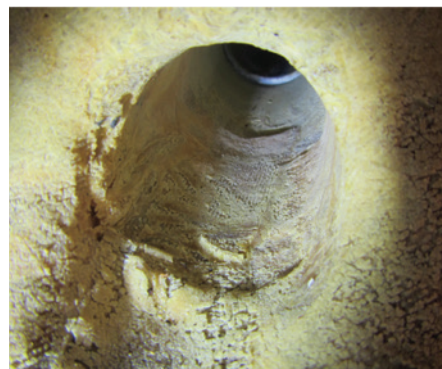
Figure 7. Tank drain damage.

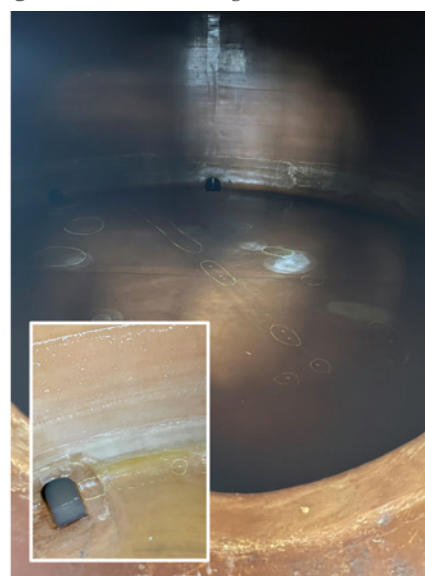
Figure 8. Damage to tank bottom, knuckle, and lower shell.

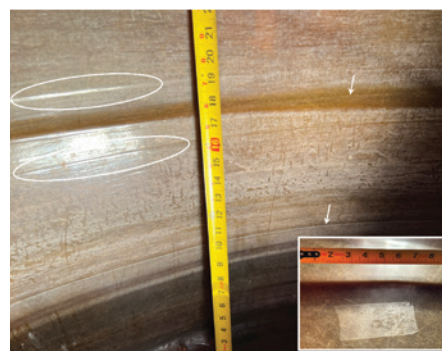
Figure 9. Imprinting of tank shell and bottom molds.

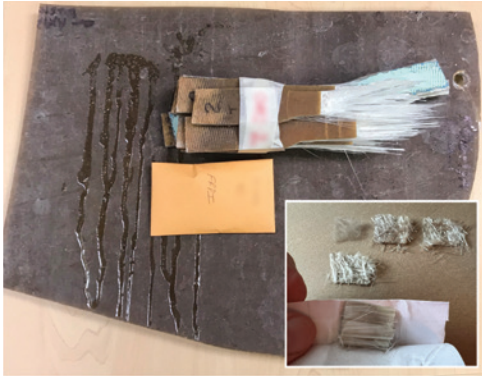
**Figure 10.** Remains of destructive test.

Inspection report auditing was accompanied by an onsite tank inspection training exercise and core specimen evaluation using the side manway cutout saved. The internal inspection found the shell and bottom inner surface fully intact, as evidence of the like-new shiny surface plus shell mylar and bottom tape mold imprinting was observed. No other damage was noted. Glass content testing also revealed an inner surface veil was present and tensile testing proved the shell to be two and a quarter times stronger than the minimum design (see **Figures 9** and **10**). The tanks were given a 15-year estimated remaining useful life and set to a five-year inspection interval. This reassessment saved the owner about \$400K over imminent tank replacement.
