# Inspectioneering Journal

## Fiberglass Storage Tank Inspection Procedures Gain Traction in the US

**VOLUME 30, ISSUE 4**

JULY | AUGUST 2024

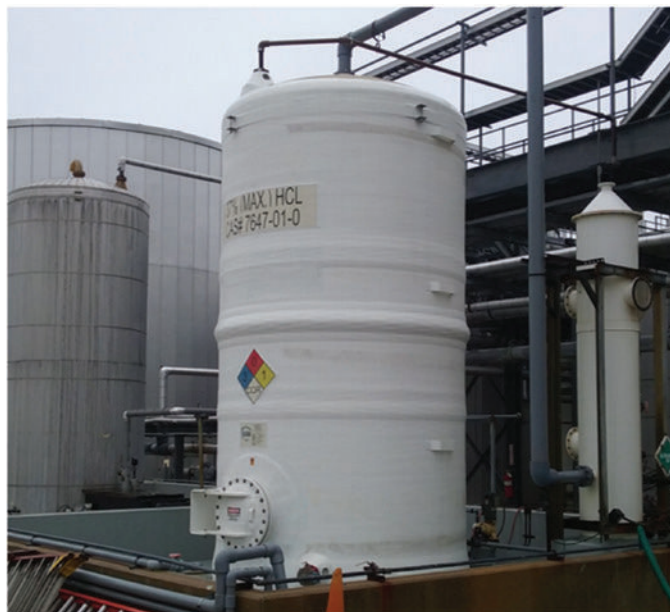
Figure 1. Hydrochloric acid tank.

US Federal and State regulations related to the storage of hazardous substances, such as hydrochloric acid (see **Figure 1**), were enacted decades ago to ensure environmental protection and worker safety. These regulations require ASTs to be inspected following the most recently promulgated Recognized and Generally Accepted Good Engineering Practices (RAGAGEP). FRPI inspection procedures are the most recent RAGAGEP per EPA guidance and OSHA interpretation, providing owners and inspectors a means of compliance with laws.

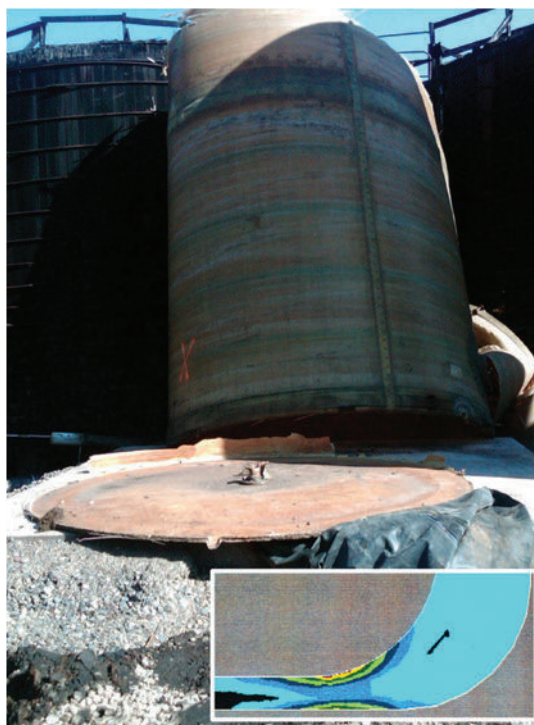
**Figure 4.** Catastrophic failure of acetic acid tank.

In this case, a 43-year-old 20,000-gallon acetic acid tank bottom suffered a catastrophic failure, spilling its contents into marginal containment. Under the NYS DEC Chemical Bulk Storage Rules and Regulations in the US, this tank had been undergoing inspections at 5-year intervals. Because it had a capacity greater than 10,000 gallons, the tank was also subject to inspection under a qualified engineer and, where necessary, an internal inspection among other suggested scope should be considered. The regulations are assumed to prevent failure, assuring environmental protection and safety.

A critical inspection zone for fiberglass ASTs is the bottom knuckle area. Finite element analysis shows the high stress zone in red (see **Figure 4**). Over time, with resin attack, permeation and stress, the bottom adjacent to the knuckle radius typically shows signs of degradation. Although possibly difficult to see, but easily considered if the inspector is properly qualified and following a detailed inspection procedure, this known failure mode could appear as inner corrosion barrier crazes and/or suggest evaluation of stress corrosion modulus decay. This catastrophic tank failure could have been prevented.

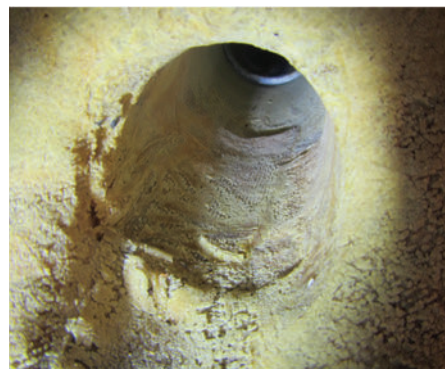
**Figure 7.** Tank drain damage.

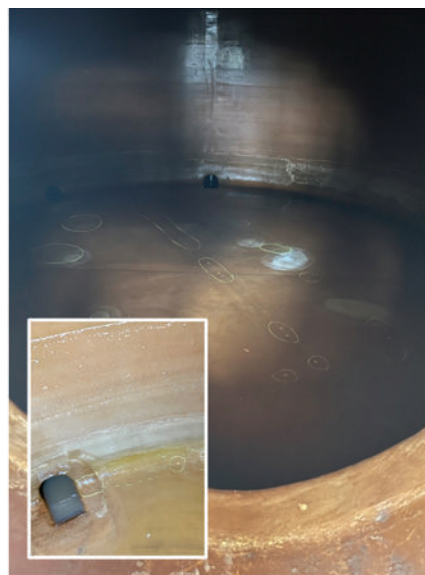
**Figure 8.** Damage to tank bottom, knuckle, and lower shell.

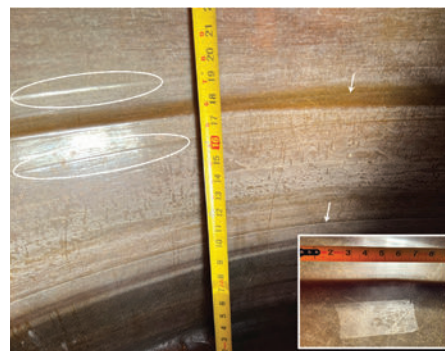
**Figure 9.** Imprinting of tank shell and bottom molds.

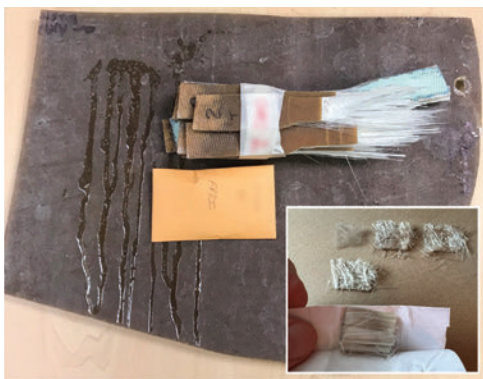
**Figure 10.** Remains of destructive test.

Inspection report auditing was accompanied by an onsite tank inspection training exercise and core specimen evaluation using the side manway cutout saved. The internal inspection found the shell and bottom inner surface fully intact, as evidence of the like-new shiny surface plus shell mylar and bottom tape mold imprinting was observed. No other damage was noted. Glass content testing also revealed an inner surface veil was present and tensile testing proved the shell to be two and a quarter times stronger than the minimum design (see **Figures 9 and 10**). The tanks were given a 15-year estimated remaining useful life and set to a five-year inspection interval. This reassessment saved the owner about \$400K over imminent tank replacement.
