## Developing Inspection and Test Plans for Fiberglass Pipe and Duct Systems

**Gary L. Arthur**, *President at Fiberglass Reinforced Plastics Institute (FRPI)*

**VOLUME 30, ISSUE 6**

NOVEMBER | DECEMBER 2024

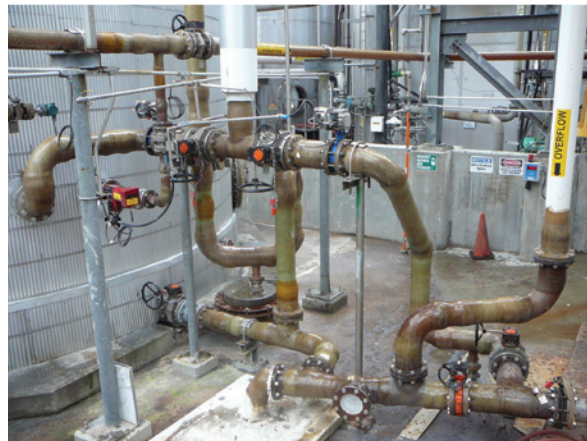
**Figure 1.** Chlorine dioxide piping.

The Fiberglass Reinforced Plastics Institute (FRPI) has just published its first standard practice for fiberglass aboveground pipe and duct system inspection. These procedures were cloned from recognized procedures for fiberglass aboveground storage tank inspection discussed in the July/August 2024 *Inspectioneering Journal* article “[Fiberglass Storage Tank Inspection Procedures Gain Traction in the US](#)” [1]. This new pipe and duct system practice enables the development and implementation of inspection and test plans for these systems, often transferring hazardous substances, such as chlorine dioxide liquid and gas. Please refer to **Figure 1**.

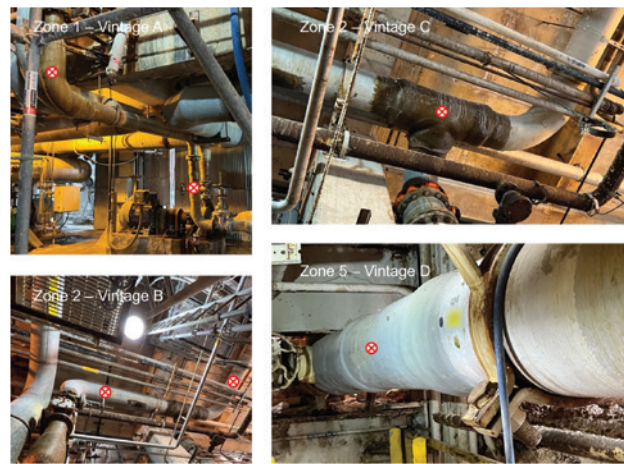
**Figure 2.** Single circuit with multiple pipe manufacturing vintages.

The net result of substitution errors is a facility ending up with an assortment of vintage designs within a single circuit and/or zone within a circuit. Multiple vintages with no marking are common and escalate the confusion. Please refer to **Figure 2**, where the pipe marked with a red “X” shows four different vintages of pipe in three of five circuit zones where the design of each is unknown. **Figure 3** exemplifies catastrophic inner corrosion barrier failure within two years of being placed in service due to an inadvertent substitution.

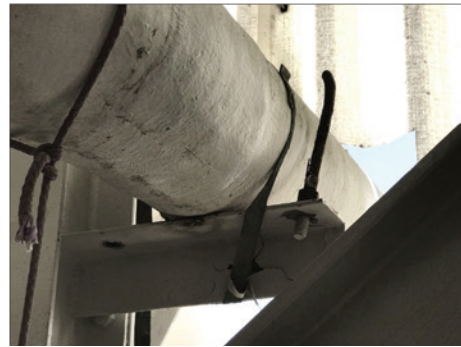
**Figure 4.** Improper pipe support.

Poor support fit-up is more prone to occur with products manufactured per ASTM D6041, D3982, and D2996 plus ASME B1.1, B31.3, and NM.2 due to their variable thickness designs and resulting outside diameters. Systems built to these standards generally require custom support, which is seldom provided. Horizontal runs require a minimum 120-degree padded saddle bearing area, where some installations skip the saddle altogether. Please refer to **Figure 4**.

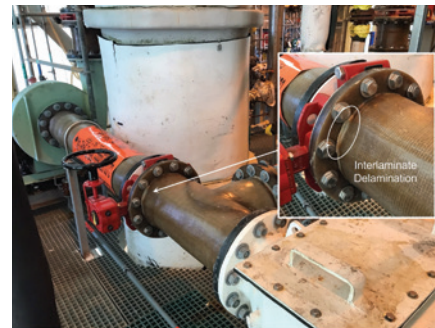
**Figure 5.** Flange hub radius interlaminar delamination.

Misalignment of flange connections are other issues that often find their way into inspection reports. Flanges in an all-flanged system being bolted up will not mate flat and parallel with other fixed flanges for all practical purposes. When this assembly challenge is not addressed at installation, an interlaminar delamination will occur over time due to the low tensile elongation properties of the flange (see **Figure 5**). Full-faced flanges mating with dissimilar raised-faced steel flanges and over-torquing to draw flanges together end up with circumferential hub radius, radial, circumferential bolt hole, and cross-sectional cracking most of the time (see **Figure 6**). Faulty ASTM D5421 flange construction is another culprit for these crack-type damage mechanisms.

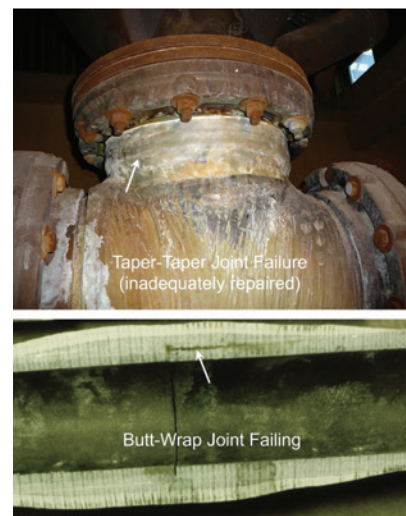
**Figure 7.** Secondary bond attack (adhesive and primary laminate).

Unqualified field installers struggling with the manufacturer's bonding procedure specifications are usually the cause of improper field joining. These issues tend to evolve into field joint adhesive and primary laminate secondary bond attack, with eventual leaking (refer to **Figure 7**).

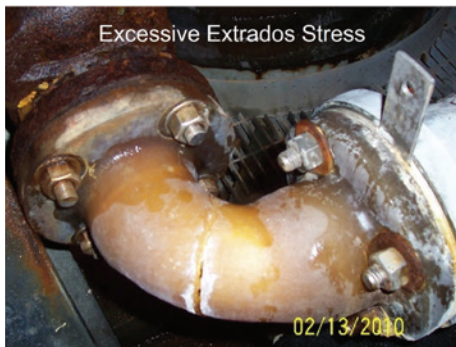
**Figure 8.** Elbow stress fracture.

Overlooked system stress may occur in the design, but poor fit-up, misalignment, and unqualified field installers may also compromise the best pipe stress analysis solution. Excessive stress may relieve itself in the form of a crack or fracture, as shown in **Figure 8**.

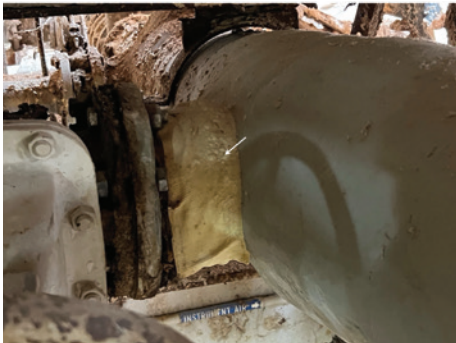
**Figure 9.** Inappropriate nozzle neck repair.

quality assurance (see **Figure 9**). Other factors that play into this gap are the question of repairability, a qualification scheme for field technicians, and sufficient time allowed to make the proper repair.
